# Arborist Survey Report

## Canyon Creek HOA

Boulder Lane  
Austin, TX

Lone Star  
Tree & Turfgrass  
Consulting Services

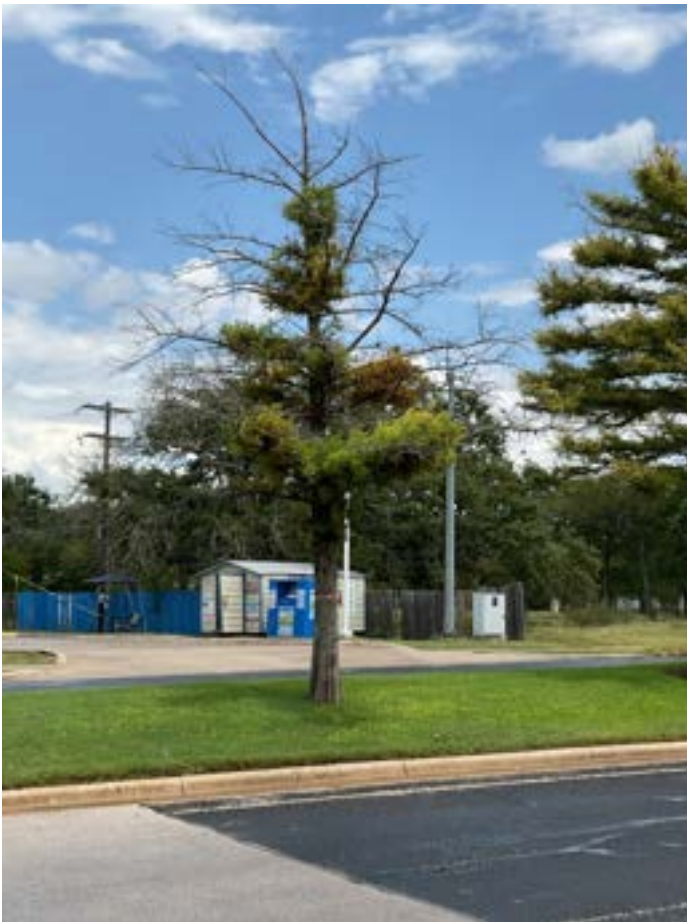
### Field Tree Survey - 1. 1

Tree Tag # (If Applicable)	1
Tree Species	Taxodium distichum - Bald Cypress
Diameter (DBH)	11
Tree Overall Health	Poor
Tree Health Issues	Weather Stress, Water Stress
Tree Health Issues Notes	Tree is showing signs of freeze damage, pruning will leave a unappealing tree. I recommend removal or no pruning at all if it is OK to wait and see if tree responds in another growing season
Tree Structure	Fair
Tree Structure Conditions	Dead Branches

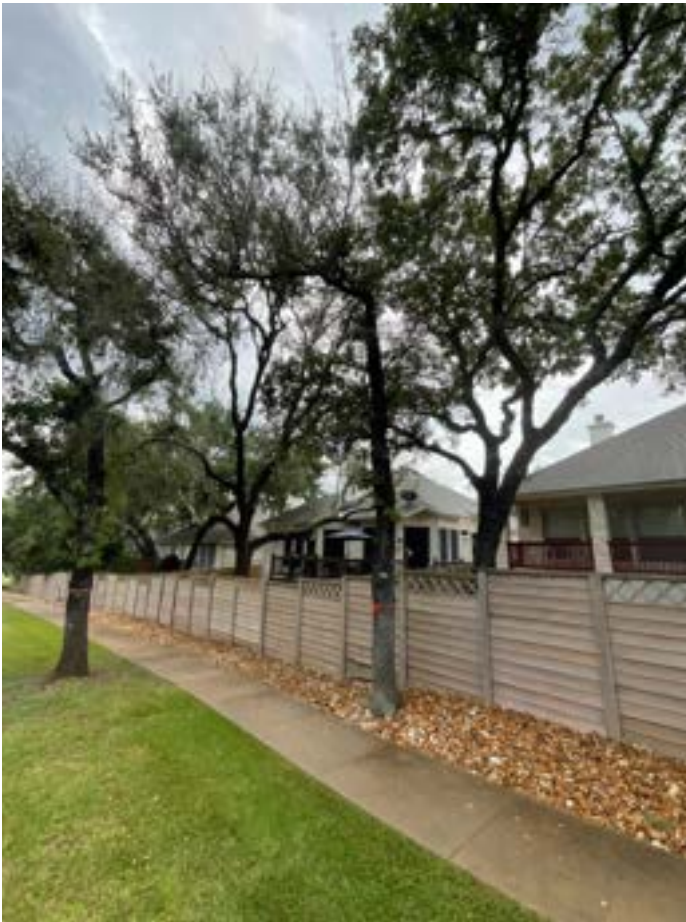
### Field Tree Survey - 2. 2

<b>Tree Species</b>	Quercus stellata - Post Oak
<b>Diameter (DBH)</b>	12
<b>Tree Overall Health</b>	Dead or Dying
<b>Tree Health Issues</b>	Weather Stress, General senescence
<b>Tree Health Issues Notes</b>	Tree has poor structure in poor health, recommend removal
<b>Tree Structure</b>	Very Poor
<b>Tree Structure Conditions</b>

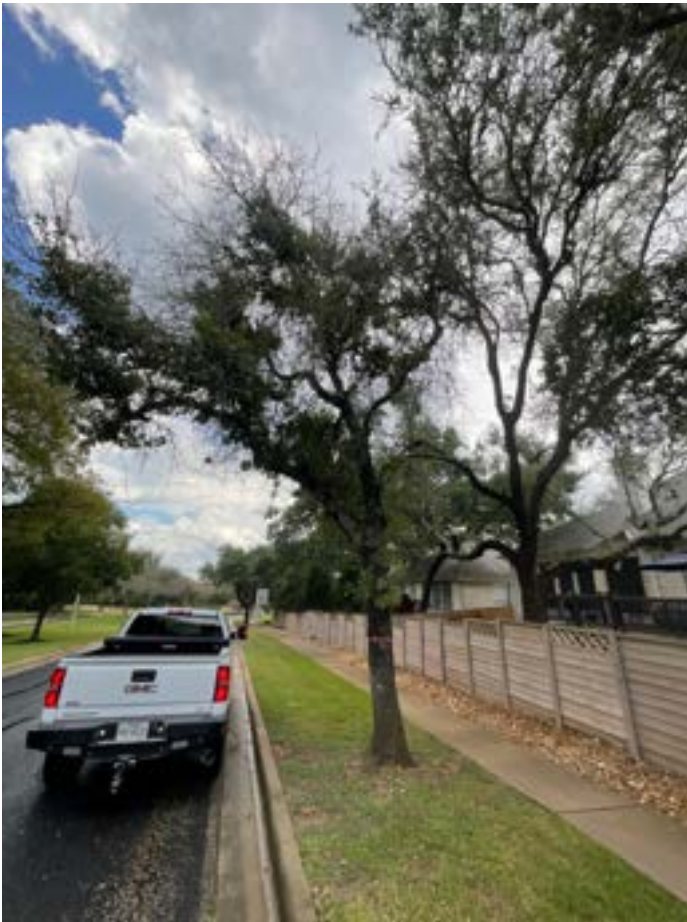
### Field Tree Survey - 3. 3

<b>Tree Tag # (If Applicable)</b>	3
<b>Tree Species</b>	Quercus stellata - Post Oak
<b>Diameter (DBH)</b>	14
<b>Tree Overall Health</b>	Poor
<b>Tree Health Issues</b>	Weather Stress, General senescence
<b>Tree Health Issues Notes</b>	Tree is suffering from a parent freeze damage, lots of deadwood and canopy, I recommend pruning deadwood as much as possible and allowing tree to recover
<b>Tree Structure</b>	Fair
<b>Tree Structure Conditions</b>

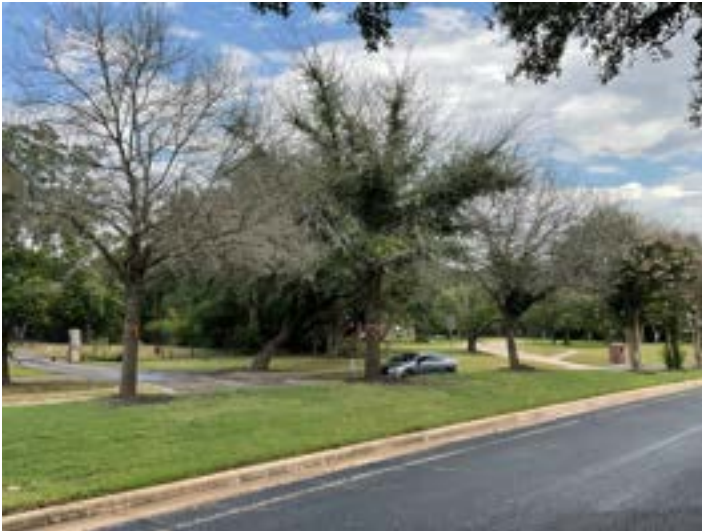
**Field Tree Survey - 4. 4**

<b>Tree Tag # (If Applicable)</b>	4
<b>Tree Species</b>	Quercus virginiana - Live Oak
<b>Diameter (DBH)</b>	12
<b>Tree Overall Health</b>	Poor
<b>Tree Health Issues</b>	Weather Stress
<b>Tree Health Issues Notes</b>	First and third trees in this grouping do not appear to show signs of adequate recovery, I recommend removal. The second tree at this location can use basic pruning to remove deadwood and hopefully allow the tree to recover.
<b>Tree Structure</b>	Good
<b>Tree Structure Conditions</b>

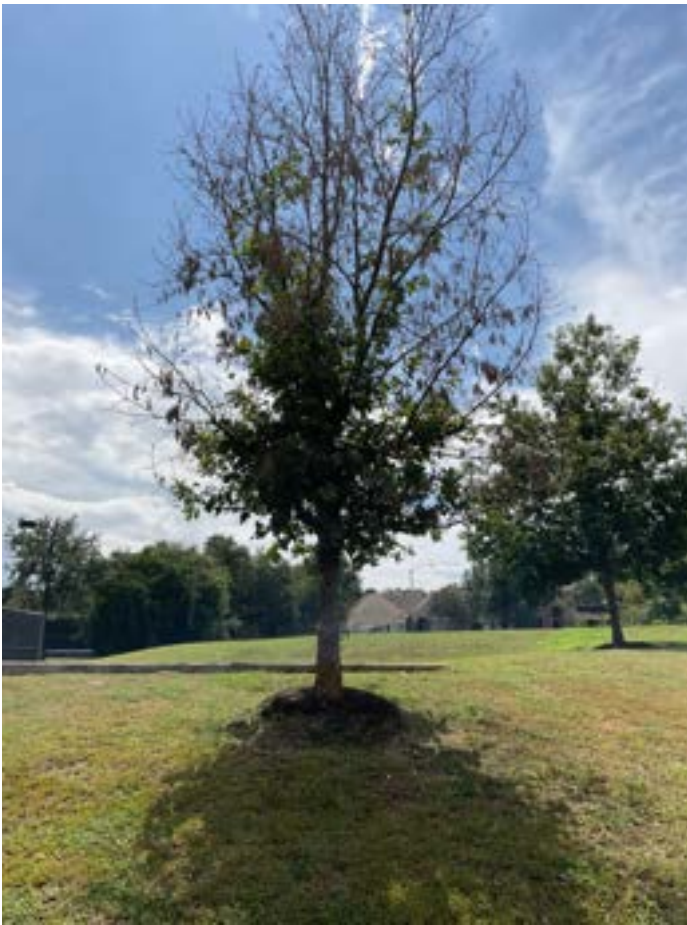
**Field Tree Survey - 5. 7**

<b>Tree Tag # (If Applicable)</b>	7
<b>Tree Species</b>	Quercus polymorpha-Monterrey Oak
<b>Diameter (DBH)</b>	8
<b>Tree Overall Health</b>	Poor
<b>Tree Health Issues</b>	Weather Stress
<b>Tree Health Issues Notes</b>	Freeze damage tree as is very common in Monterey Oaks after a winter storm, recommend removal
<b>Tree Structure</b>	
<b>Tree Structure Conditions</b>

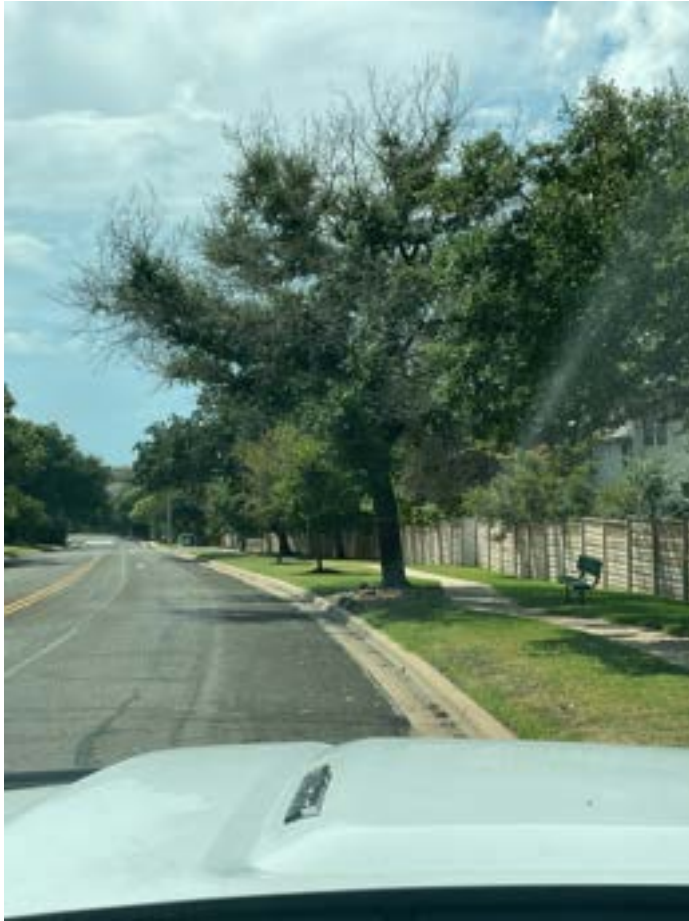
**Field Tree Survey - 6. 8**

Tree Tag # (If Applicable)	8
Tree Species	Quercus virginiana - Live Oak
Diameter (DBH)	15
Tree Overall Health	Poor
Tree Health Issues	Weather Stress

<b>Tree Health Issues Notes</b>	Several dead limbs and branches consistent with freeze damage. I feel on most oaks in this condition, especially Live Oaks, it is too early to make a call on mortality. I recommend pruning and waiting until next spring to allow for recovery
<b>Tree Structure</b>	
<b>Tree Structure Conditions</b>

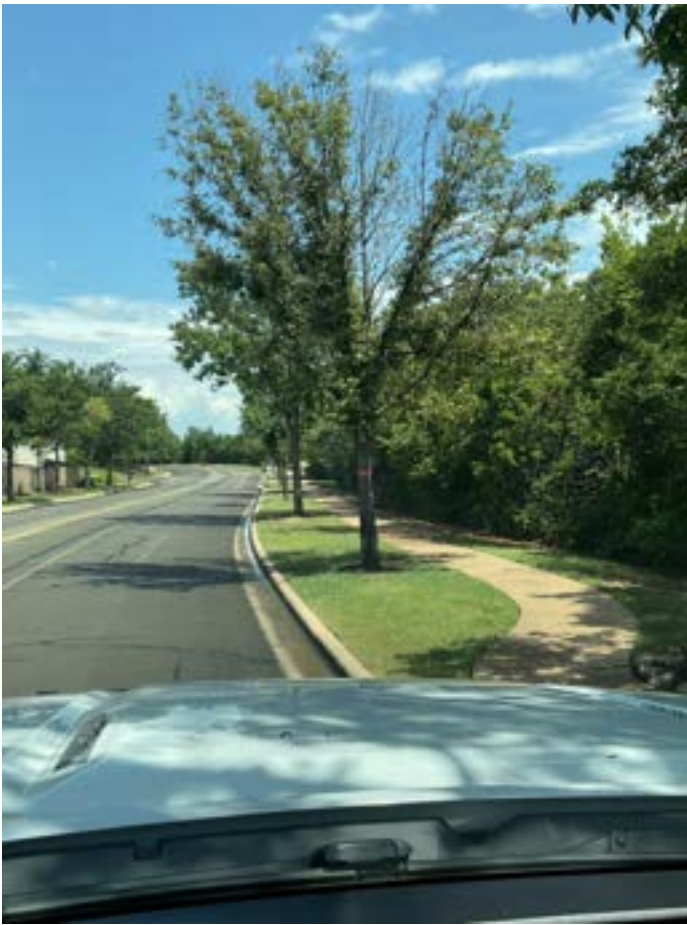
**Field Tree Survey - 7. 9**

<b>Tree Tag # (If Applicable)</b>	9
<b>Tree Species</b>	Quercus polymorpha-Monterrey Oak
<b>Diameter (DBH)</b>	8
<b>Tree Overall Health</b>	Poor
<b>Tree Health Issues</b>	Weather Stress
<b>Tree Health Issues Notes</b>	Tree has quite a bit of foliage, but pruning the tree to remove deadwood would result in removal of the central leader. Removing the central leader can cause structural and other issues in the future. I would recommend removal of the tree
<b>Tree Structure</b>	Poor
<b>Tree Structure Conditions</b>

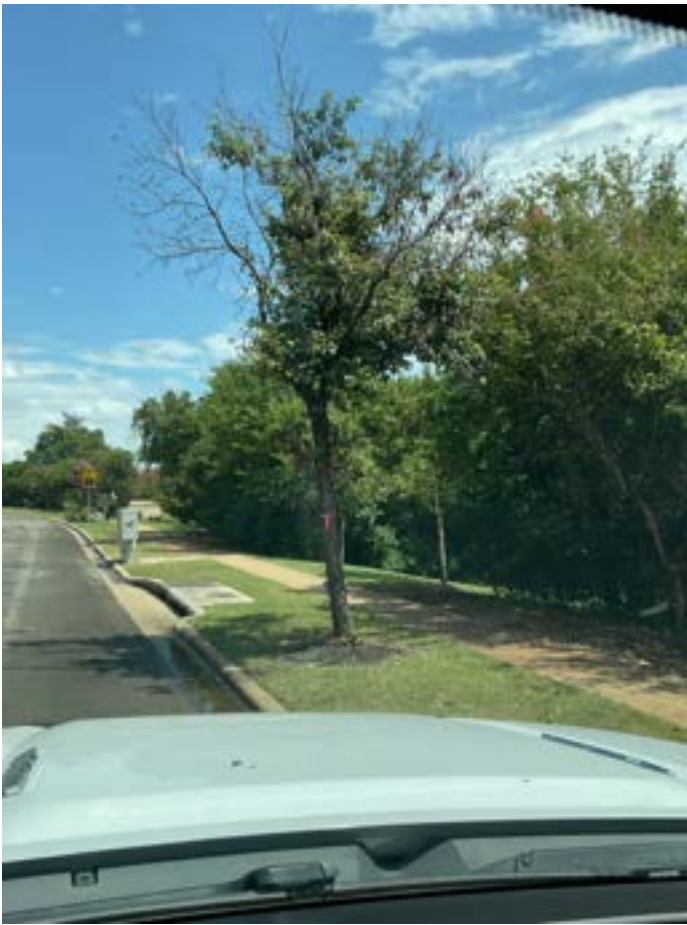
**Field Tree Survey - 8. 10**

<b>Tree Tag # (If Applicable)</b>	10
<b>Tree Species</b>	Quercus polymorpha-Monterrey Oak
<b>Diameter (DBH)</b>	7
<b>Tree Overall Health</b>	Poor
<b>Tree Health Issues</b>	Weather Stress
<b>Tree Health Issues Notes</b>	Removing deadwood from this tree will result in a very ugly tree. If it is OK with those involved, I am OK with this tree staying and only deadwood removed, just understand that it will not be very appealing. Also, This tree may never recover fully to be a healthy tree, even in 5 to 10 years
<b>Tree Structure</b>	Poor
<b>Tree Structure Conditions</b>

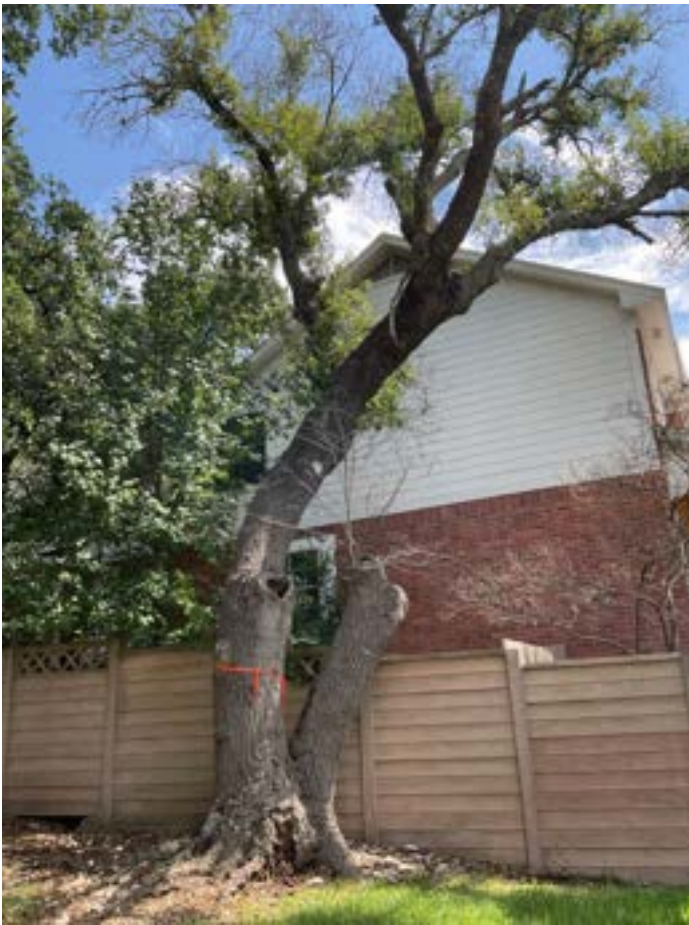
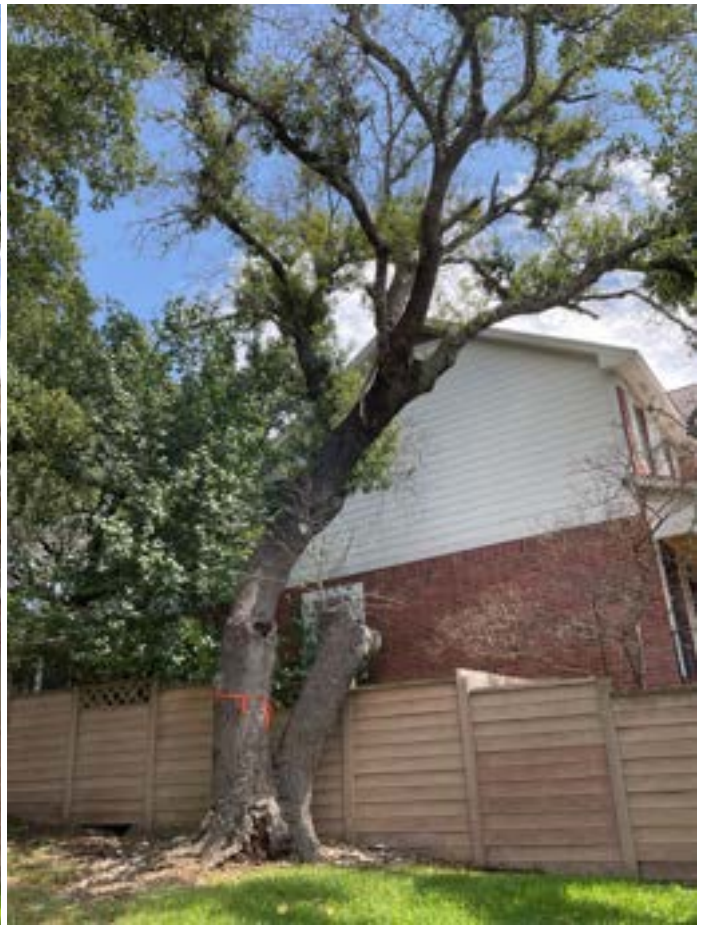
**Field Tree Survey - 9. 11**

<b>Tree Tag # (If Applicable)</b>	11
<b>Tree Species</b>	Quercus texana buckleyi - Texas Red Oak
<b>Diameter (DBH)</b>	22
<b>Tree Overall Health</b>	Dead or Dying
<b>Tree Health Issues</b>	Weather Stress, Fungal Issues, Physical Damage, Significant decay
<b>Tree Health Issues Notes</b>	This tree appears to be in declining health, significant decay throughout the lower trunk, and high risk of impact and damage in the event of a tree failure. I recommend removal
<b>Tree Structure</b>	Very Poor
<b>Tree Structure Conditions</b>	Cavities, Conks, Cracks, Decay, Dead Branches, Dead/Missing Bark

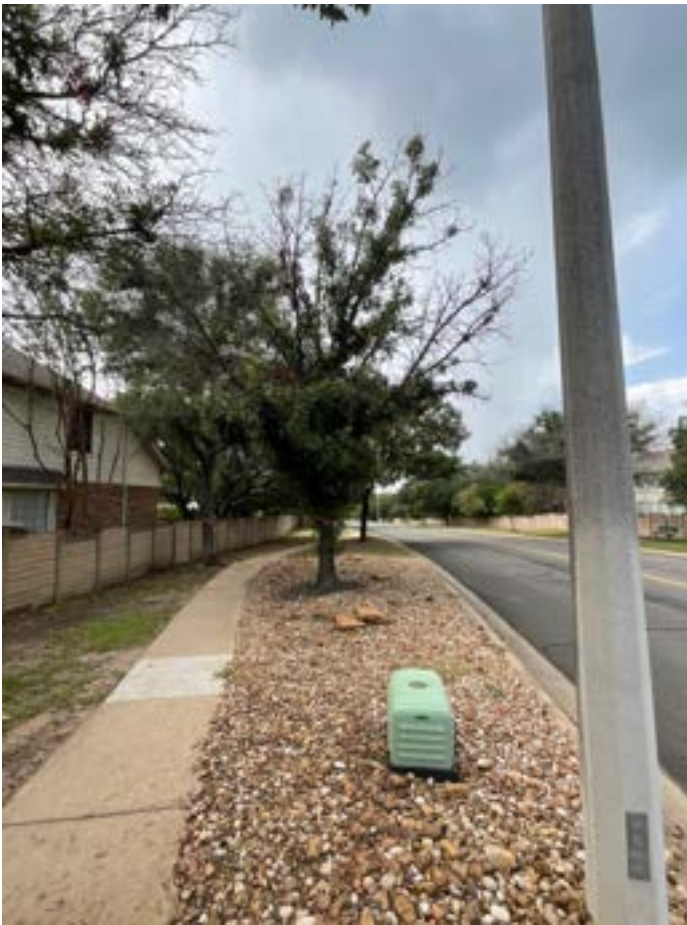
**Field Tree Survey - 10. 12**

<b>Tree Tag # (If Applicable)</b>	12
<b>Tree Species</b>	Quercus macrocarpa - Burr Oak
<b>Diameter (DBH)</b>	14
<b>Tree Overall Health</b>	Dead or Dying
<b>Tree Health Issues</b>	Weather Stress, Fungal Issues, Insect Damage
<b>Tree Health Issues Notes</b>	Tree has both fungal and insect damage present, pruning of the tree would not yield a structurally sound and ugly tree. I would recommend removal.
<b>Tree Structure</b>	Poor
<b>Tree Structure Conditions</b>

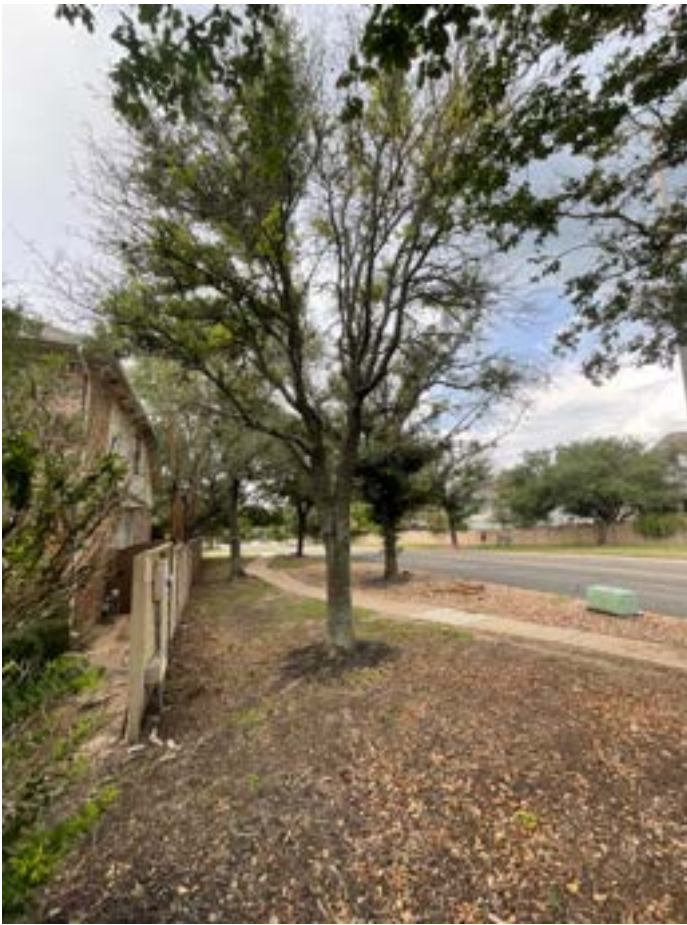
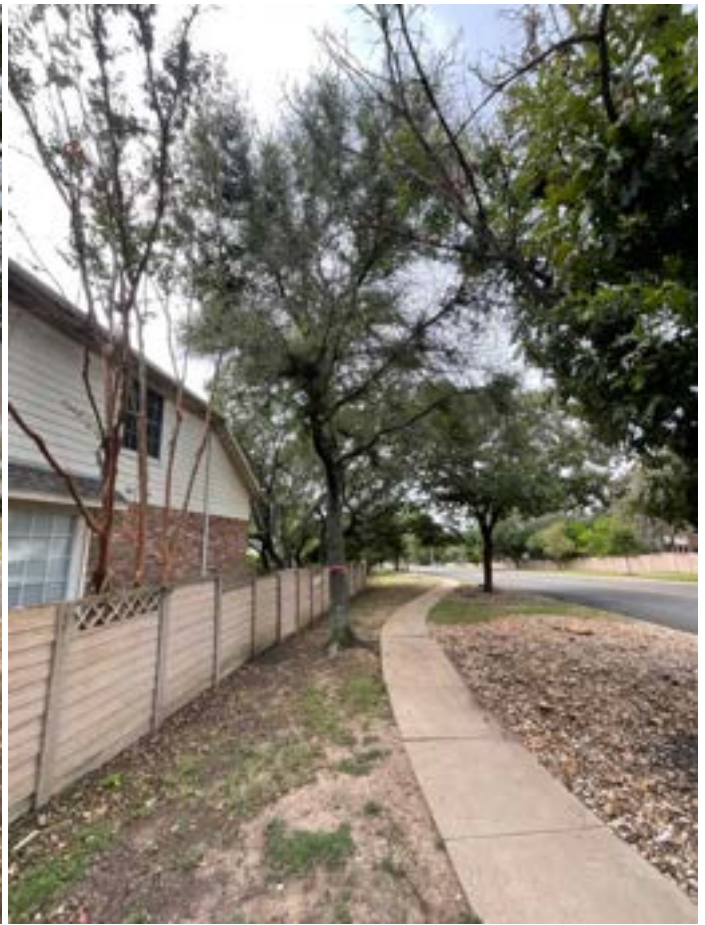
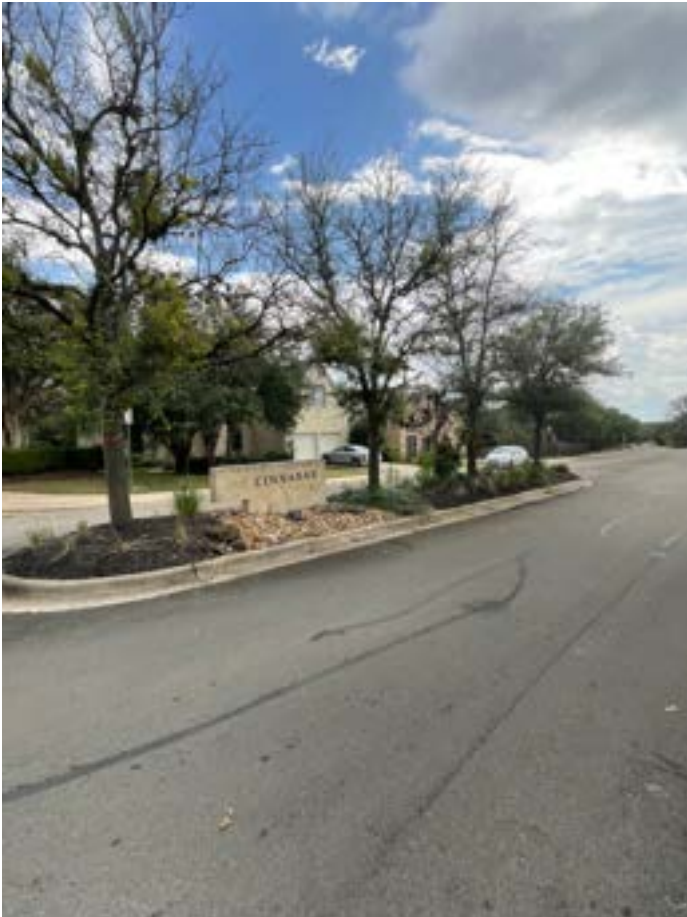
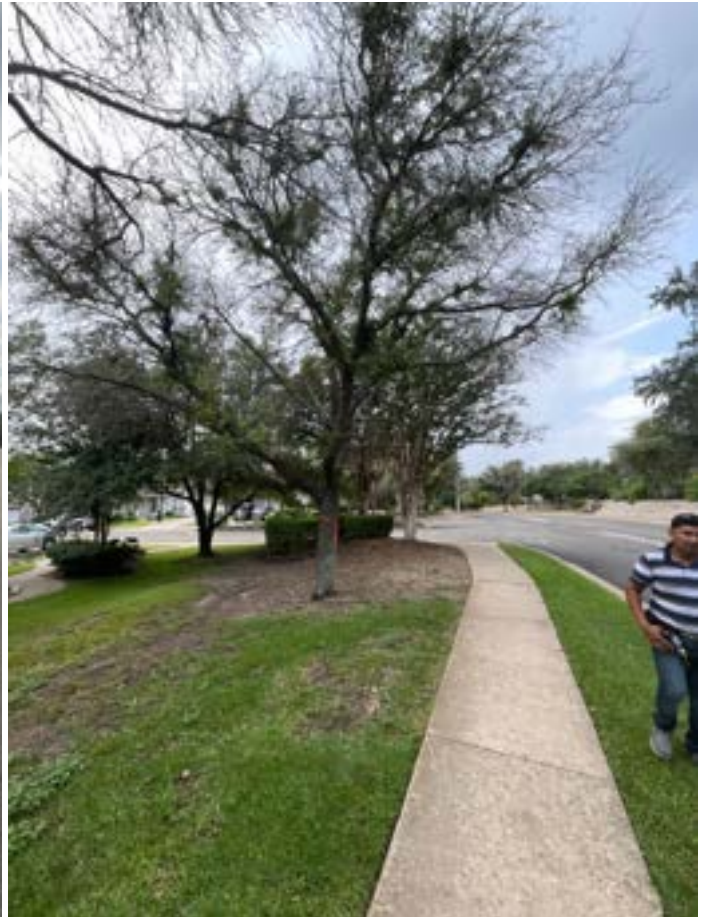
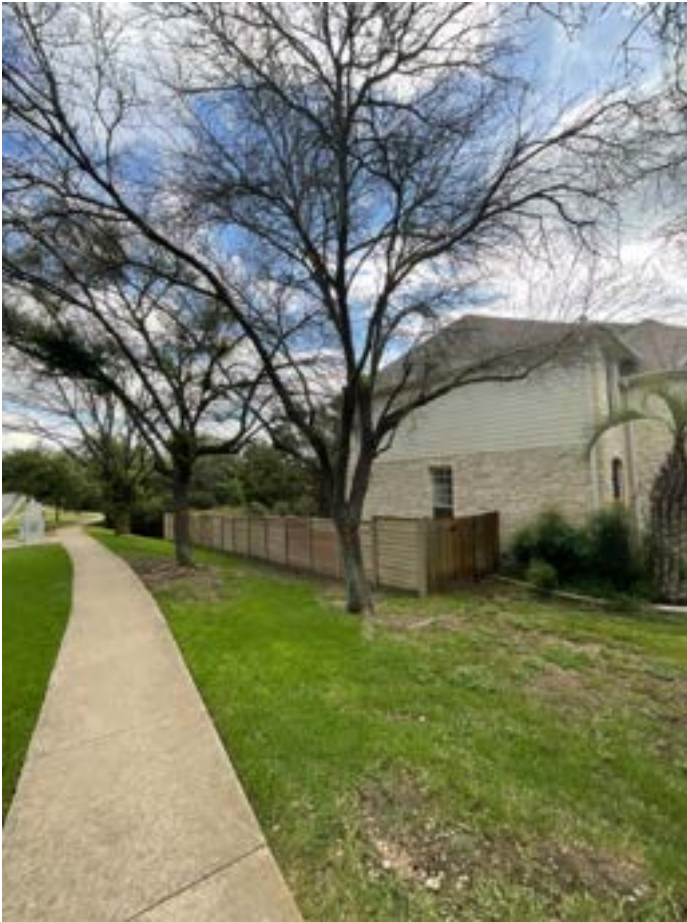
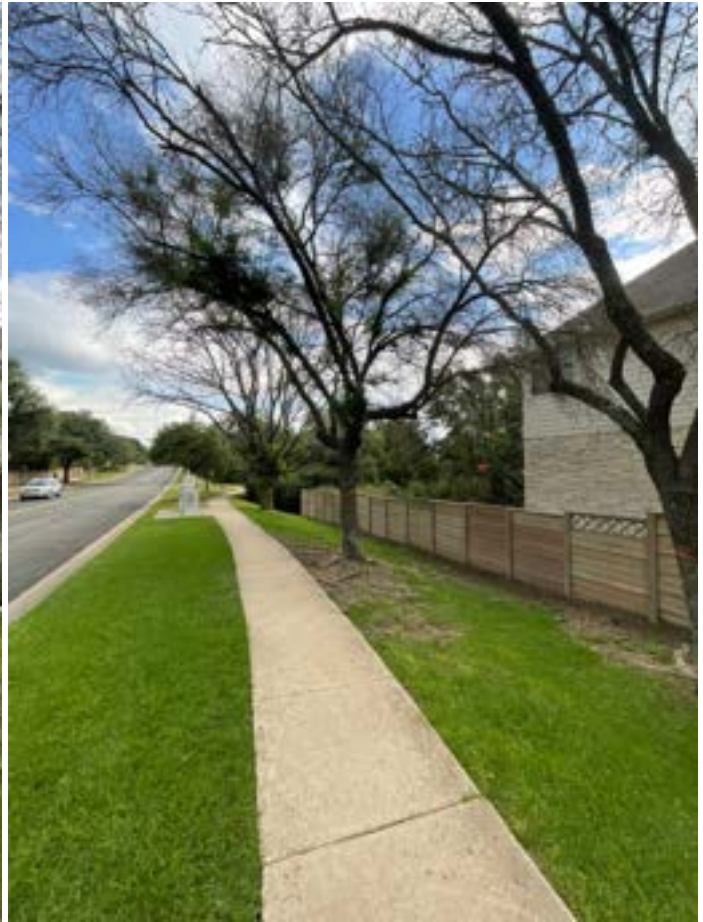
**Field Tree Survey - 11. 13**

<b>Tree Tag # (If Applicable)</b>	13
<b>Tree Species</b>	Quercus virginiana - Live Oak
<b>Diameter (DBH)</b>	
<b>Tree Overall Health</b>	
<b>Tree Health Issues</b>	Weather Stress
<b>Tree Health Issues Notes</b>	There are eight Live Oaks in question at the intersection of Boulder Lane and Cinnabar Trail. For almost all of these trees I do not see an adequate way to prune and maintain structural integrity of the tree. If you would like to wait to see if these trees rebound next year, I would recommend no pruning at all, just leave them be as pruning would be an unnecessary cost. Otherwise these trees can be marked for removal now.
<b>Tree Structure</b>	Good
<b>Tree Structure Conditions</b>

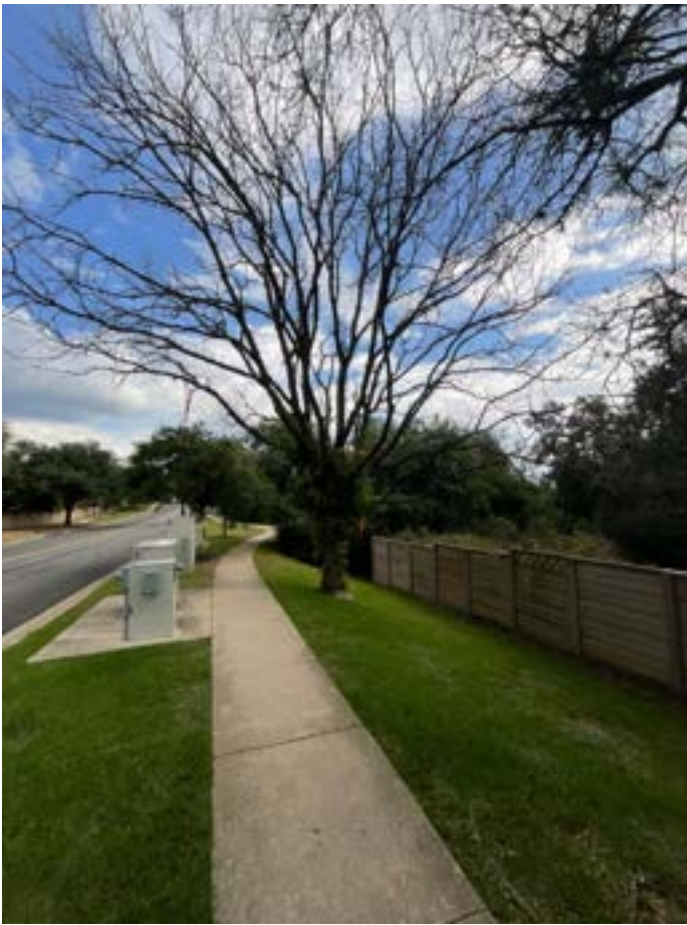
### Field Tree Survey - 12. 14

<b>Tree Tag # (If Applicable)</b>	14
<b>Tree Species</b>	Quercus macrocarpa - Burr Oak
<b>Diameter (DBH)</b>	15
<b>Tree Overall Health</b>	Dead or Dying
<b>Tree Health Issues</b>	Weather Stress
<b>Tree Health Issues Notes</b>	This tree does not show adequate signs of regrows in the canopy, I recommend removal.
<b>Tree Structure</b>	
<b>Tree Structure Conditions</b>

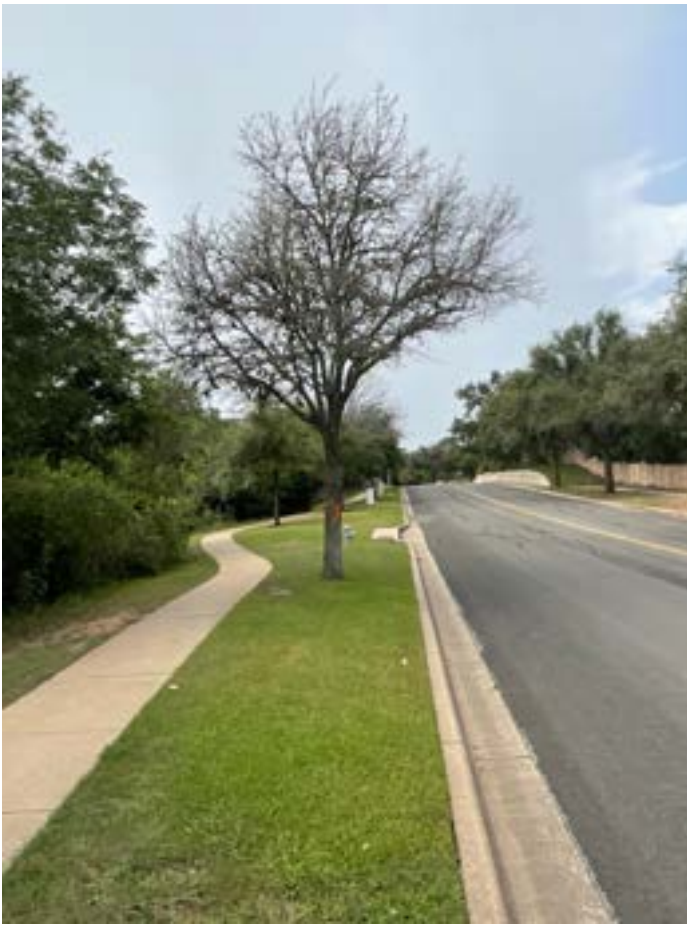
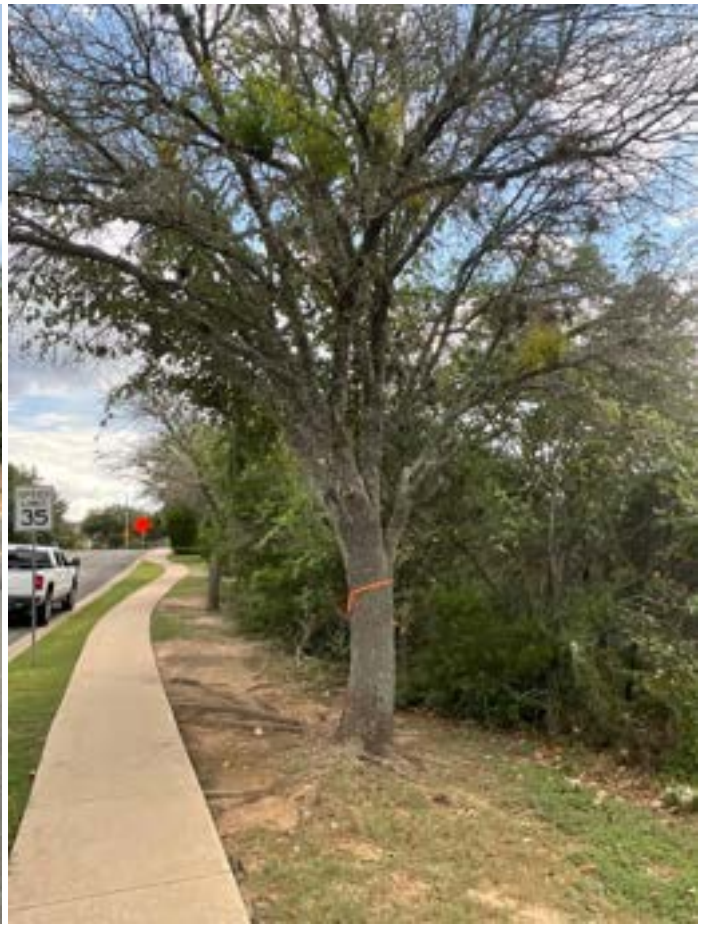
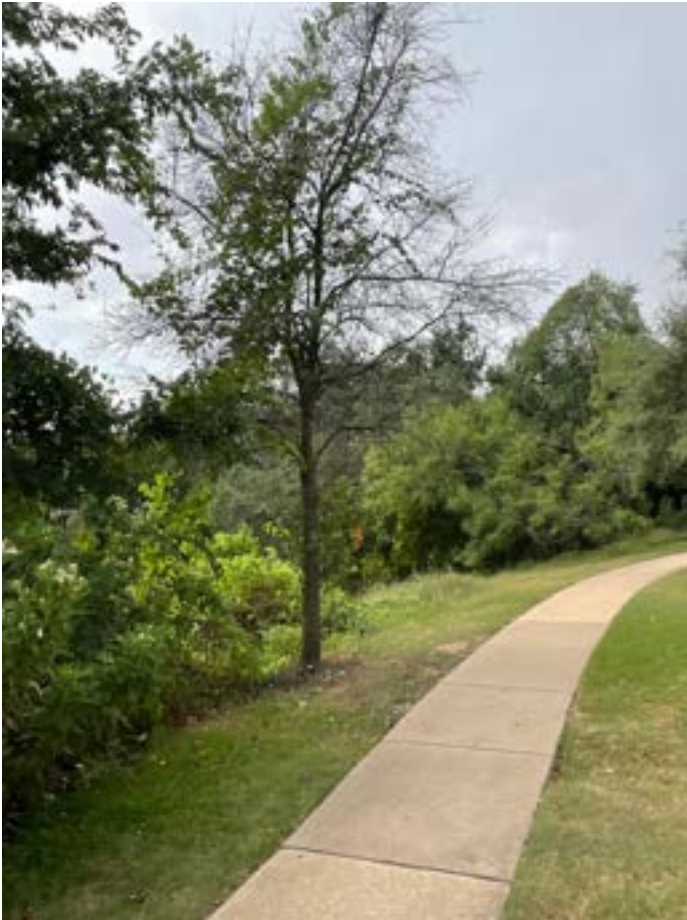
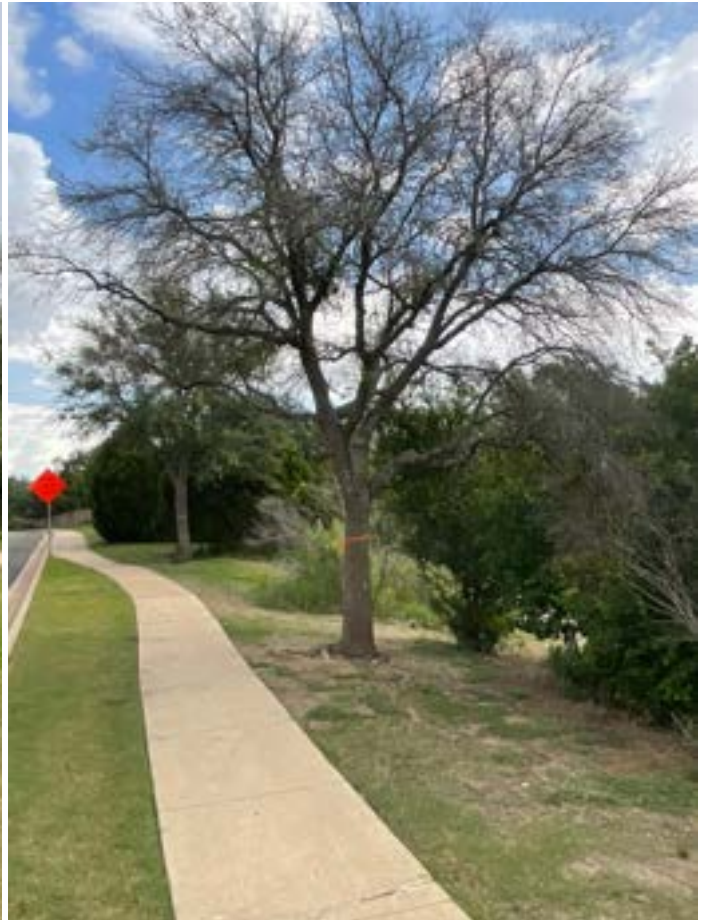
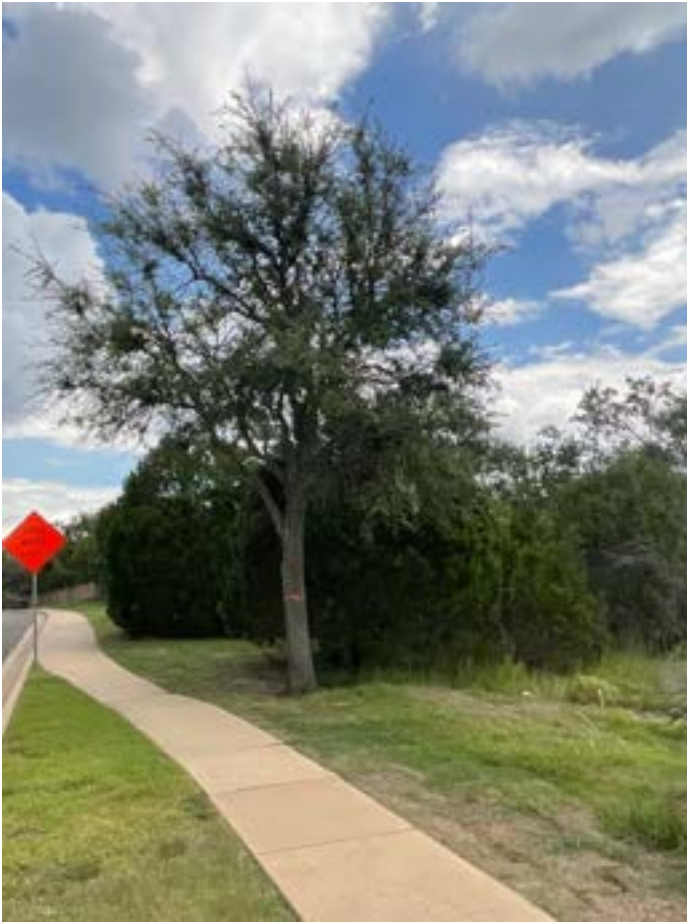
**Field Tree Survey - 13. 15**

<b>Tree Tag # (If Applicable)</b>	15
<b>Tree Species</b>	Quercus virginiana - Live Oak
<b>Diameter (DBH)</b>	10
<b>Tree Overall Health</b>	Dead or Dying
<b>Tree Health Issues</b>	Weather Stress
<b>Tree Health Issues Notes</b>	There are six trees in question at this location all our Live Oak. Five of them show little to no signs of regrowth in the canopy and can't be marked for removal. The one farthest to the north shows adequate regrowth in canopy and do not recommend pruning or removal.
<b>Tree Structure</b>	
<b>Tree Structure Conditions</b>

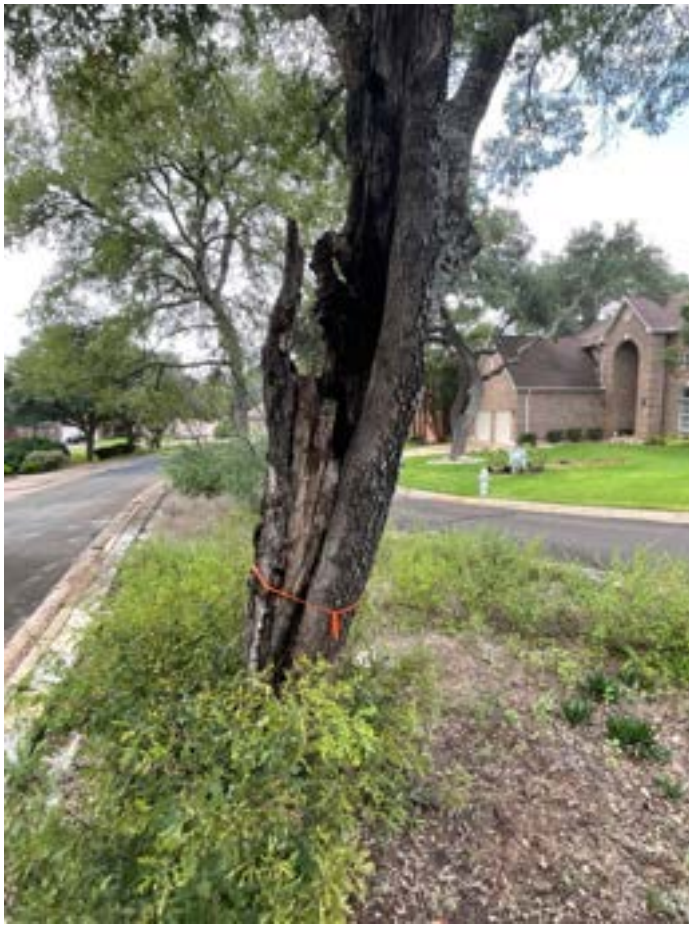
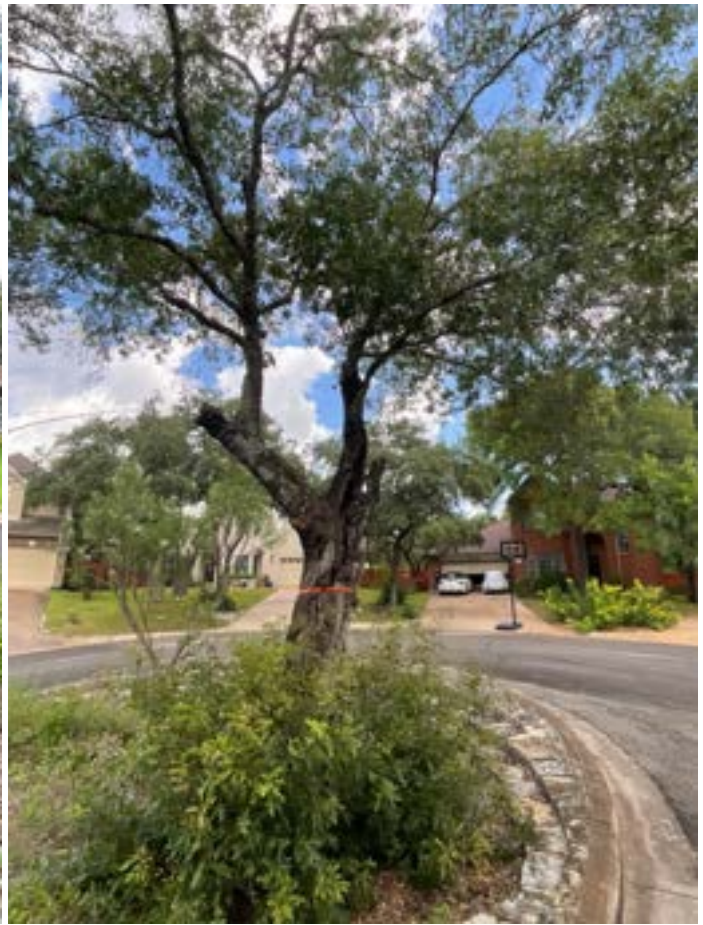
### Field Tree Survey - 14. 16

<b>Tree Tag # (If Applicable)</b>	16
<b>Tree Species</b>	Quercus texana buckleyi - Texas Red Oak
<b>Diameter (DBH)</b>	18
<b>Tree Overall Health</b>	Poor
<b>Tree Health Issues</b>	Weather Stress, Fungal Issues, Physical Damage
<b>Tree Health Issues Notes</b>	This tree still has plenty of foliage in the canopy, but there is a very significant amount of decay in the trunk. I recommend removal for safety reasons as this tree would classify as an eminent threat of failure
<b>Tree Structure</b>	Poor
<b>Tree Structure Conditions</b>	Cavities, Cracks, Decay, Dead Branches, Dead/Missing Bark

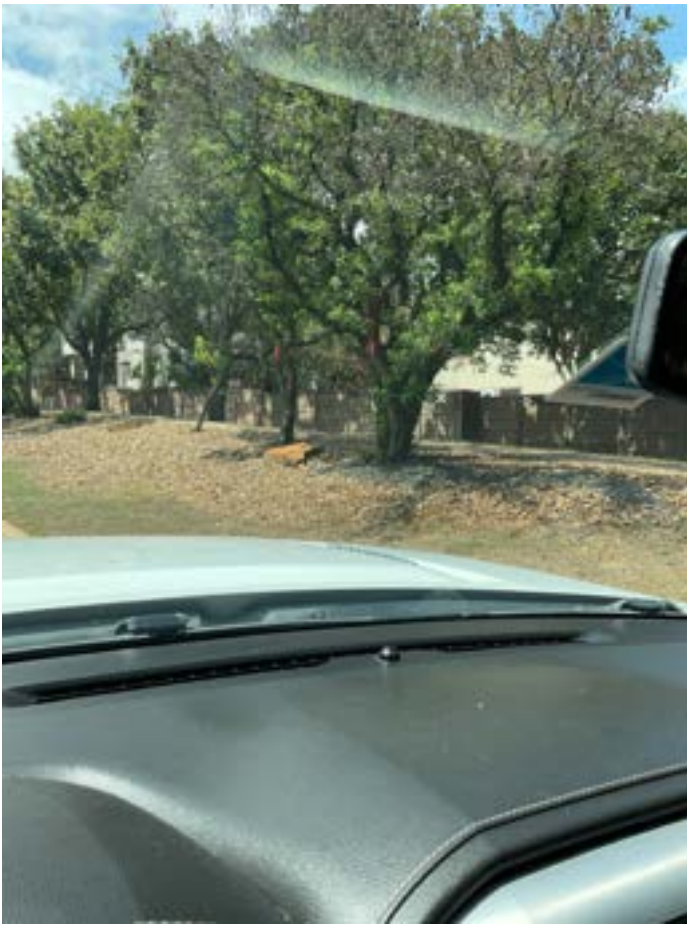
**Field Tree Survey - 15. 17**

<b>Tree Tag # (If Applicable)</b>	17
<b>Tree Species</b>	Sophora secundiflora - Texas Mountain Laurel
<b>Diameter (DBH)</b>	6
<b>Tree Overall Health</b>	Poor
<b>Tree Health Issues</b>	Weather Stress, Fungal Issues, Physical Damage
<b>Tree Health Issues Notes</b>	Mountain laurels marked for removal in this area show signs of general senescence in addition to freeze damage. These mountain laurels are very mature and will most likely never make a full recovery if allowed to stay. I recommend removal
<b>Tree Structure</b>	
<b>Tree Structure Conditions</b>
